Hol(e)y Repower!

A Gulf Coast yard gives a Hatteras a new life in 90 days

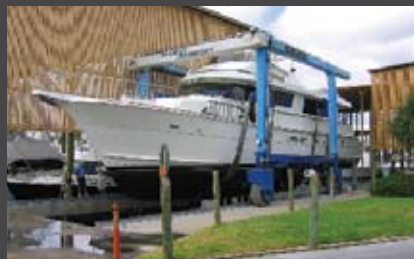
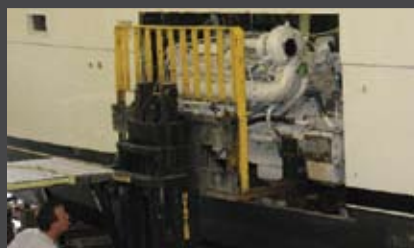
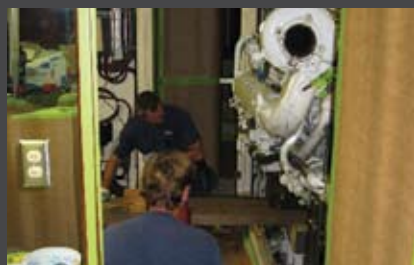
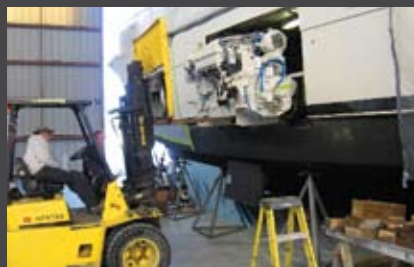
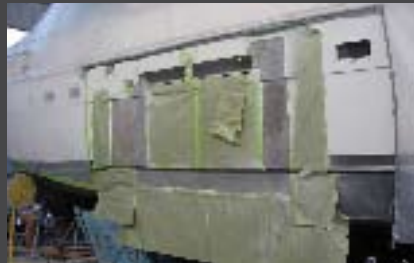
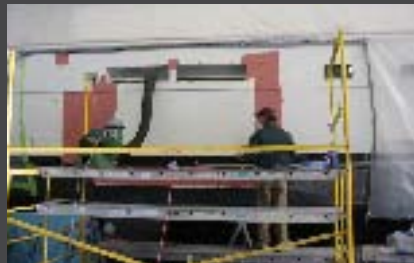
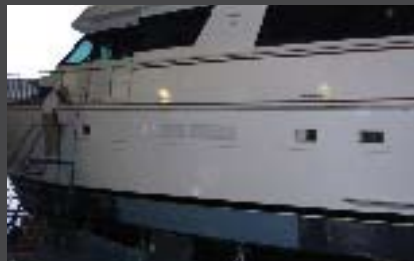
From top left: Kaybird comes out of the water; the old V-12s come out of the hull; as seen from the hallway, the starboard engine has been lifted and will slide across to port for removal; Murray Loper positions a new engine for insertion; with the original hull panel back in place, fiberglass was ground away prior to building up a new skin; the fairing process; the finished hull and a lighter Kaybird.

Once the Saunders team had cut the hole in the port side, drained all the engine and transmission fluids and tied off the hoses and the electrical connections, the engines were disconnected from their beds. Murray and Michael Dunlavy created jacks and jigs in place to raise and slide the old 5,400-pound engines. Simple comealongs winched the port engine out to the point it could be lifted with a forklift. Then the interior walls came out and the lift-and-slide technique was repeated with the starboard engine, followed by the transmissions.

beds in place the process was repeated in reverse, made easier by the fact the new engines were 1,200 pounds lighter.

Of course, the tricky bit was repairing the hullside. To piece the fiberglass, the hull laminate had to be ground back on an angle to create in essence a flange inside and out, joining old and new glass and spanning the void of the cut itself. Using a gel stripper, a worker ground away a predetermined amount of glass creating what's called a V-trench. Then, with various weights of cloth and using the heaviest mat inside, the fabrication team rolled layers of fiberglass and resin around the cut.

"Today's resins are so much better, I didn't have any concern about the strength of the patch," said Mark. When the resin had cured, Saunders' paint crew was rushed into action to make the work look it had never happened both inside and out.

"To keep to the owner's schedule, there wasn't time to paint the entire boat. We simply blended the new paint to match the old, but I'd defy you to find where it begins and ends," said John Fitzgerald, president of the yard.

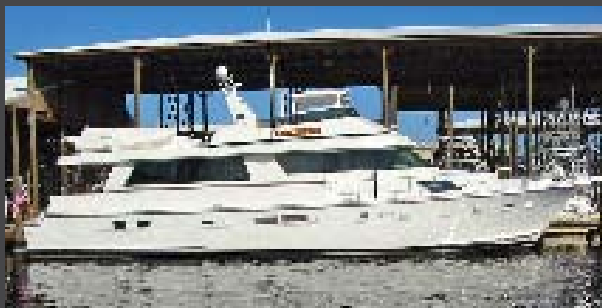
Working on the theory that the less holes in a boat, the better, Saunders Yachtworks replaced powerplants in two separate engine rooms through one hole in the hullside. Systems Technician Bruce Forehand shows the neat cut work.

To make the cutout for removing the engines, Murray started from the top line dimensions of the engine room air intake box. "I wanted to keep the cut as small as possible," he said. "The new engines [Series 60 MTUs] are actually smaller and lighter than what we were taking out, although they are slightly more [825] horsepower." Although both old and new engines were rated for the same rpms and had the same gear ratios, the owner chose to replace the old transmissions with new ZF gears just to make sure the entire power train was new.
